SUBJECT : SAFETY OF HILL SLOPES AROUND NAINI TAL.

Geological report on the stability of the Hillside at Naini-Tal by Mr. J.B. Auden.

**REPORT**  
ON THE  
**SAFETY OF CERTAIN AREAS**  
IN  
**NAINI TAL**  
**1939**

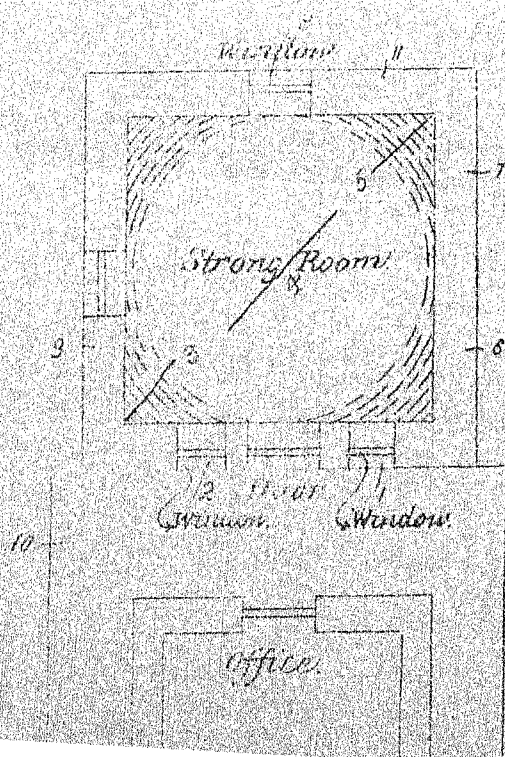
*Table of measurements of cracks in the Treasury strong room.*

*Cracks in building.*—The cracks noticed last year in the treasury strong room have not increased in width to any appreciable amount, but the diagonal crack which was only visible last year in the floor (No. 4 on plan) and in the south-west corner (No. 5 on plan) is now visible, also at 2, 3 and 9 in the north-east corner. The cracks are in no way serious. Tell-tales have been placed in eleven places and periodical measurements are made of them. The following sketch and table show the position of the tell-tales and the measurements recorded :—

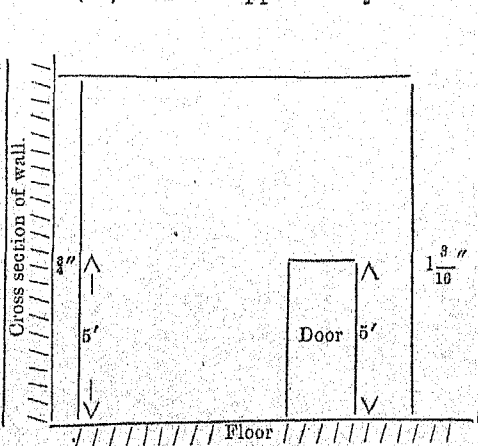
- (9) The floor of the corridor from end to end has cracked considerably and has now been thoroughly repaired.
- (10) In the staff quarters there are considerable cracks in the east wall of the north room over each of the doors, and minor cracks in other parts shown on plan.

- (11) Besides these, there are numerous minor cracks over almost all openings in the lower storey of the building. These are detailed on the plan.
- (12) In the upper storey there is a corresponding crack to that in the lower in

the corridor arches, which was filled and papered over in 1881, and which has since shown no sign of increase, as the paper on the arches is unbroken. There is also a separation between the upright woodwork at the end of the corridor and the wall, as shown in margin, but this cannot be depended on as evidence of separation in the building to the extent indicated, as much may be due to shrinkage of the wood.

5. (ii) *Probable causes of the present defective state of the building.*—The Committee is unanimously of opinion that the cracks, which are all longitudinal, were consequent upon the general disturbance of the hill during the cyclone of September 1880.

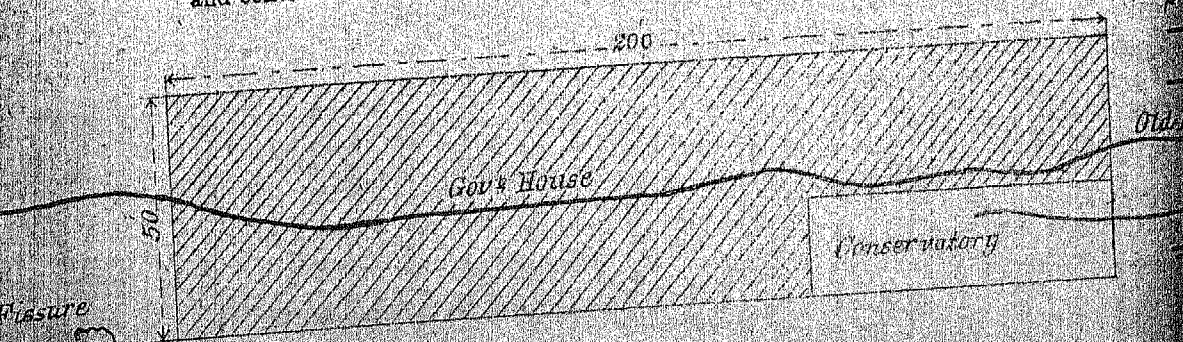
IN re-roofing the conservatory, the pillars that had got out of plumb, and gave rise to suspicions about the failure of the foundations, have been set up straight. Two small slate slabs have been let in, at ground level, on either side of the passage, and a steel bar has been made to fit accurately between them. This bar will be kept on the spot, and any subsidence of the outer wall can be, by this means, easily detected. I do not propose to enter into the question of the cracks but in opening up the drains on the east and west of the house, certain cracks, and fissures were noticed, of which I subjoin a sketch. They are not, I believe, any new thing, but are a part of the natural composition of the hill showing movement of expansion and contraction only under atmospheric changes.

The thin red lines show cracks, and the thick irregular lines fissures in the rock, two or three inches wide at the top.

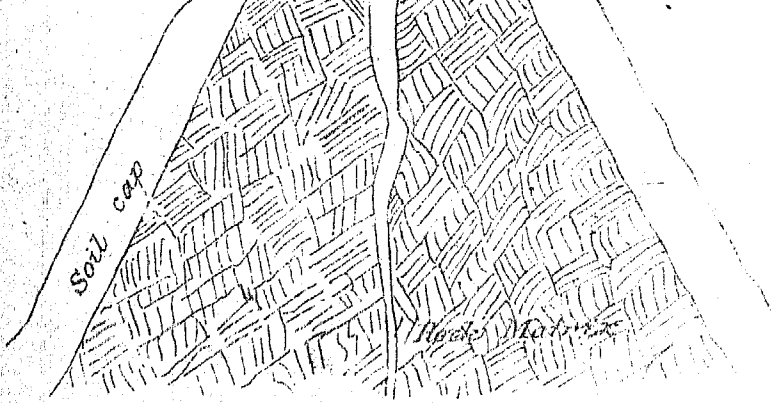
This question is one in which I have taken the deepest interest since 1881, when Colonel Brownlow informed me that he had been told that under Government House there was a fissure down which a stone if dropped could be heard falling for several seconds. I pointed out the indications of this crack or fissure to Mr. Oldham, and

showed him traces of it from Government House to and through "St. Cloud" and on to "Snow View," and he agreed with me that it is no movement of the soil-cap overlying the rocky matrix of the hill, but a distant separation through the axis of the hill itself as roughly indicated in the margin in an exaggerated manner.

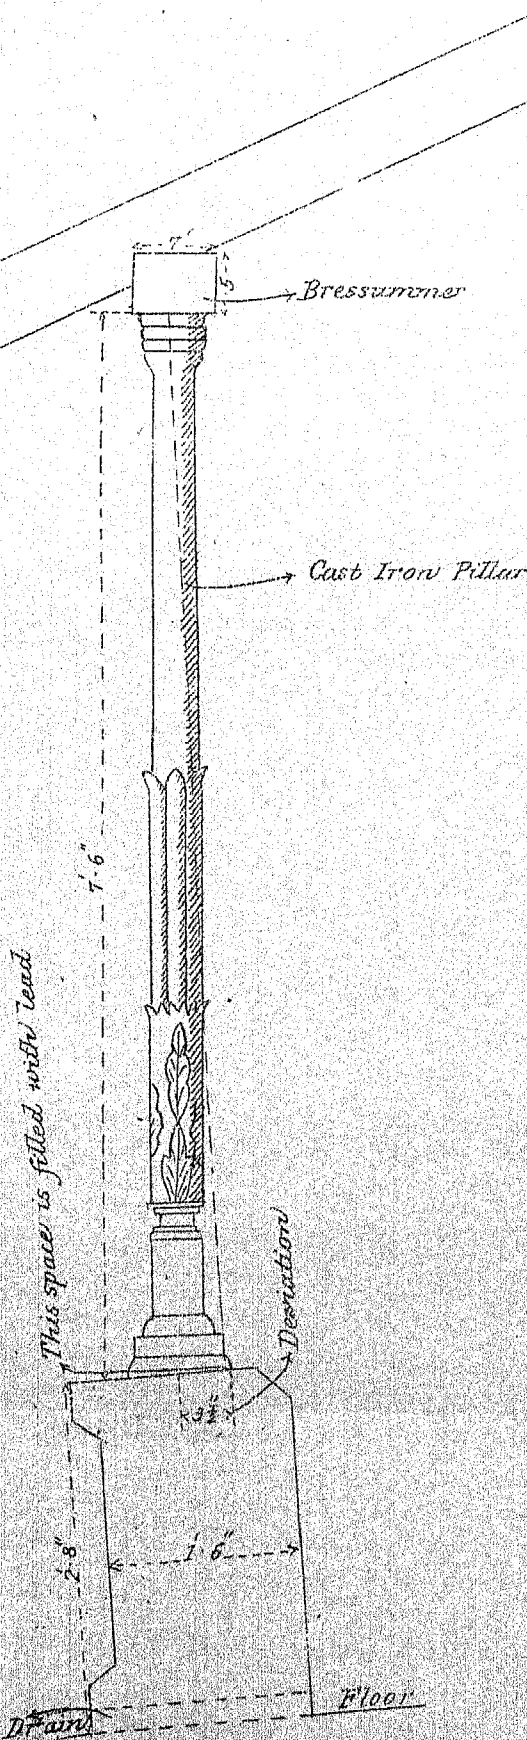
The origin or cause of this separation, and to what extent it has already gone within the hill, it is impossible to ascertain. The surface indications during the last two years show a movement of about one-eighth to a quarter of an inch only. Judging from the separation in the tiled flooring of the corridor and conservatory, and gauged by the deviation of the outer pillars of the conservatory from the vertical, it would appear that since the erection of the house in 1880 the forward movement had not exceeded three inches to  $3\frac{1}{2}$  inches as sketched in the margin.

runs at a considerable depth through the solid rock" most probably is. In my opinion the opening of the cracks a month or so after the rain ceases has no connection with the "movement" in the hill, but is due merely to the shrinkage of the materials as the temperature rises under the warm sun of September and October, and is an incident of no significance. I am also inclined to think that at present there is little, if any, movement going on: the fissure is a very large one, and extends to a great depth into the mountain; it has never been filled in to the bottom, and I believe that the periodical opening out of cracks in the corridor conservatory, garden, and in the adjacent compounds is due to the shrinkage and breaking up of the materials with which the upper portion of the chasm has been stuffed and their falling down in small particles.

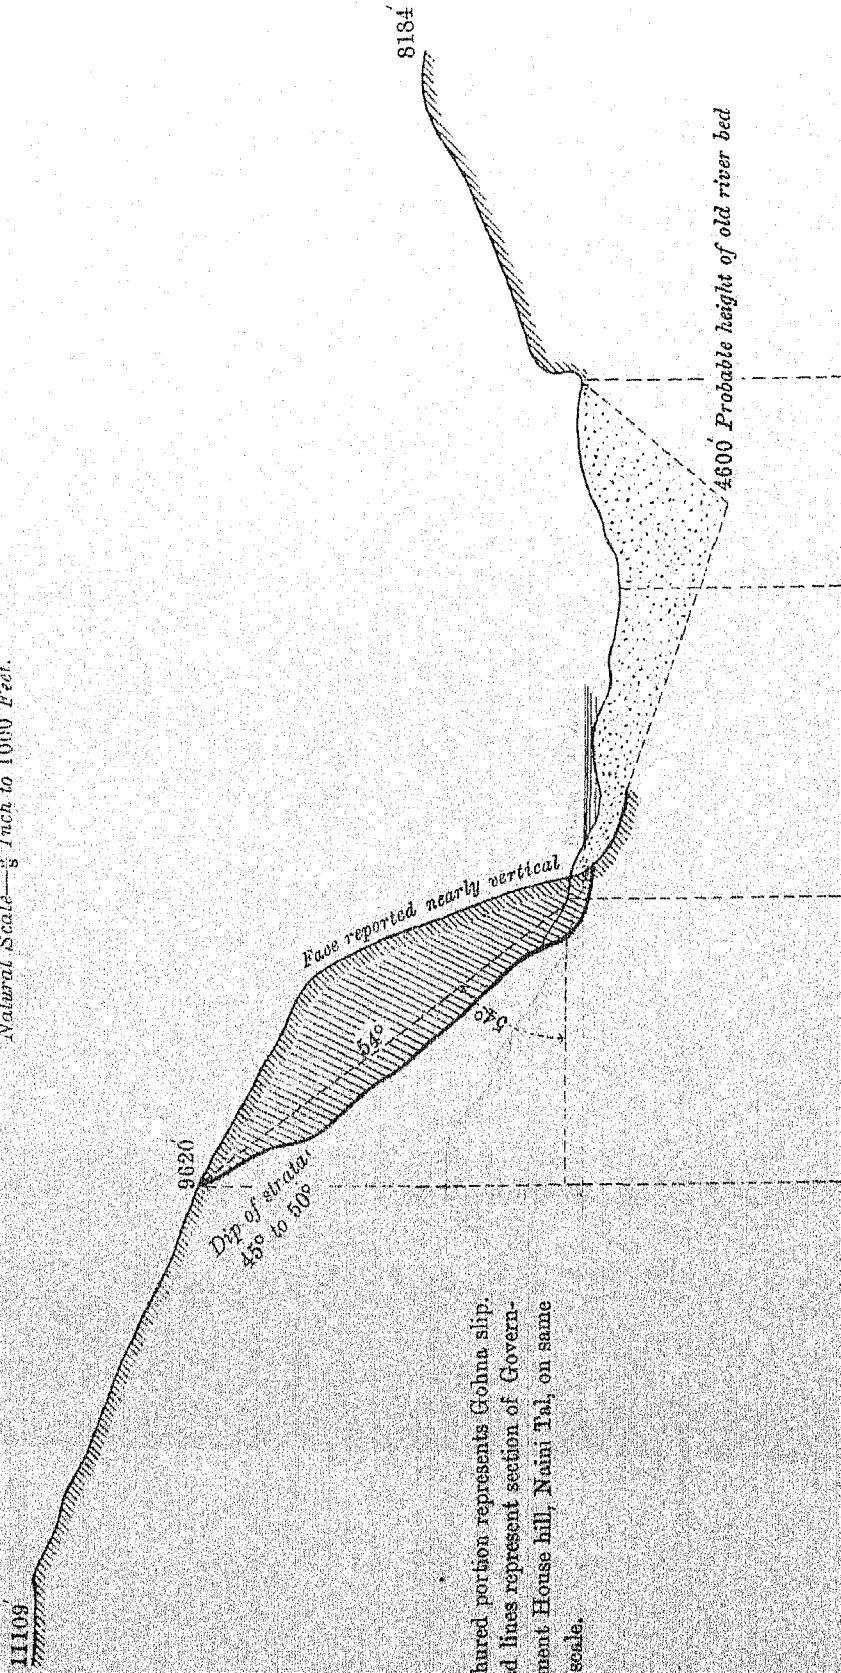
SECTION OF GOVERNMENT HOUSE HILL, NAINI TAL.

*Note*—Hachured portion represents Gobna slip.  
Red lines represent section of Government House hill, Naini Tal, on same scale.
